Faux Beaver Dam Installation and Evaluation in the Potlatch Watershed

During the summer of 2016, Latah Soil and Water Conservation District (LSWCD), Alta Science and Engineering, and other partners installed structures intended to mimic natural beaver dams (Faux Beaver Dams or FBDs) on two creeks on private properties in the Potlatch Watershed: Corral Creek and Big Bear Creek. The circumstances on these two creeks are different, so design, installation procedures, and outcomes also differ.

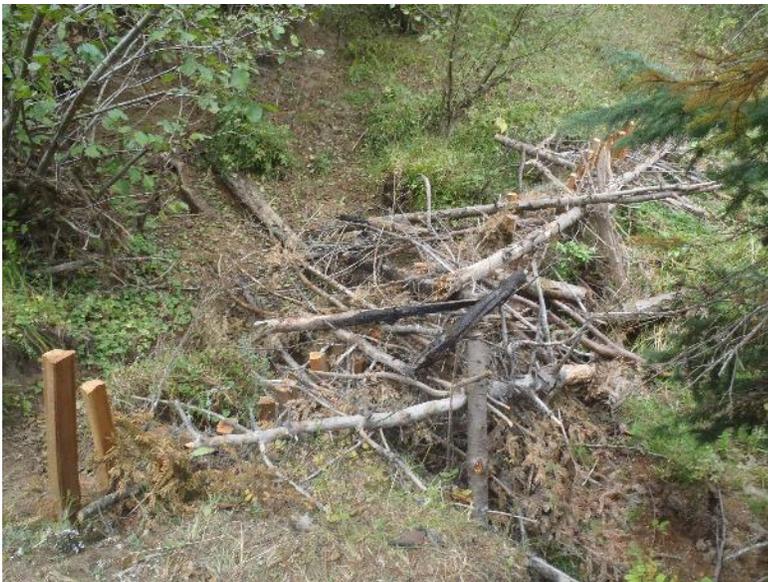
Figure 1. Corral Creek FBD After Installation

installed slightly staggered 4-inch cedar posts in the streambed using a hydraulic post pounder. Next they tamped a “wedge” of rock and mud along the upstream side of the post row. Slash and branches harvested from nearby pine, fir, and spruce trees were woven through the post row. In some cases, they placed rows of sticks on top of the slash parallel to flow and angled along both sides of the structure to help prevent scour around the posts (Figure 1).

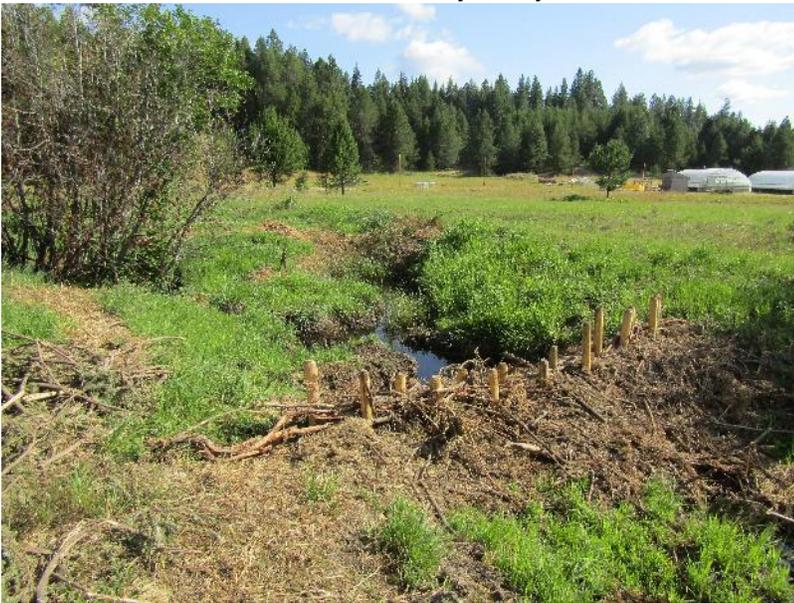
to drive 6-inch untreated wood stakes into the streambed and place slash, brush, and woody debris on and around the posts. A newly constructed FBD is shown in Figure 2.

Figure 2. New FBD in Big Bear Creek.

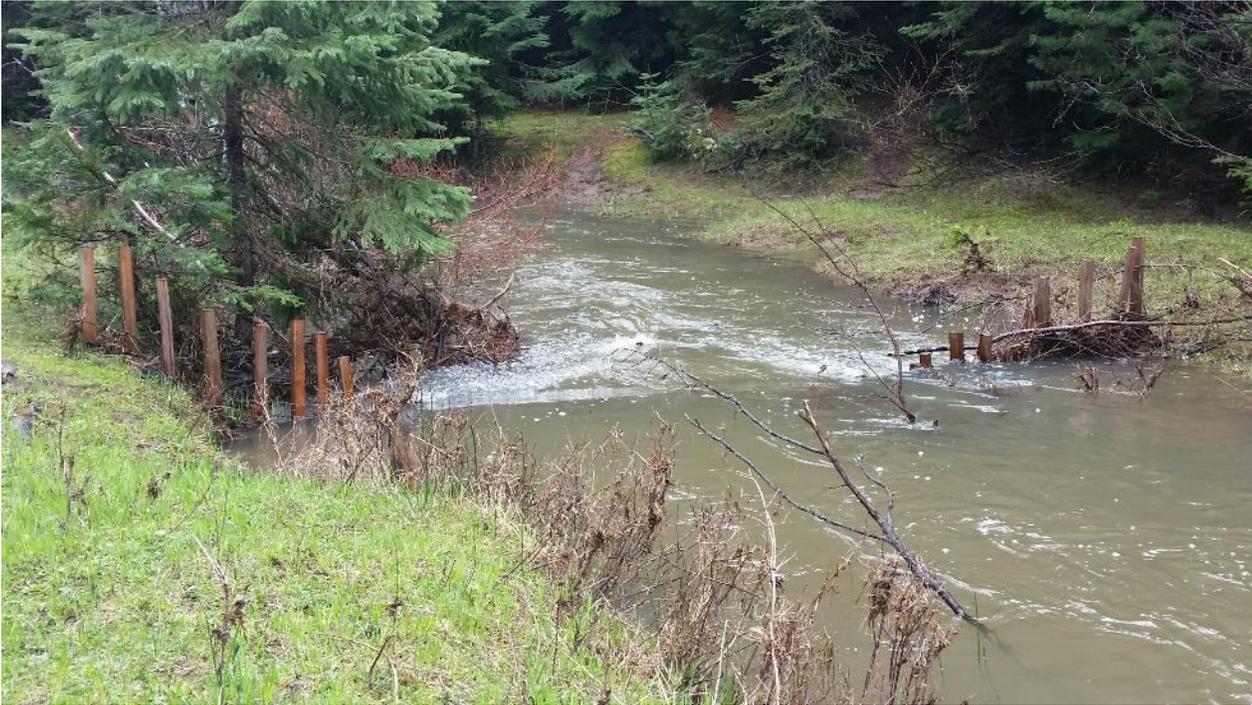
At both sites the FBDs were largely submerged at high flow. As the flow started to recede, evidence of backwatering behind the structures was noted in some, but not all cases (Figure 3). In all cases fish passage routes were observed around or over FBDs. The structures were providing backwater and upstream flooding. The aerial photo in Figure 4 shows a FBD on Big Bear Creek during high flow. It is mostly submerged, and contributing to extensive meadow flooding.

Figure 3. FBD on Corral Creek during receding flood flow.

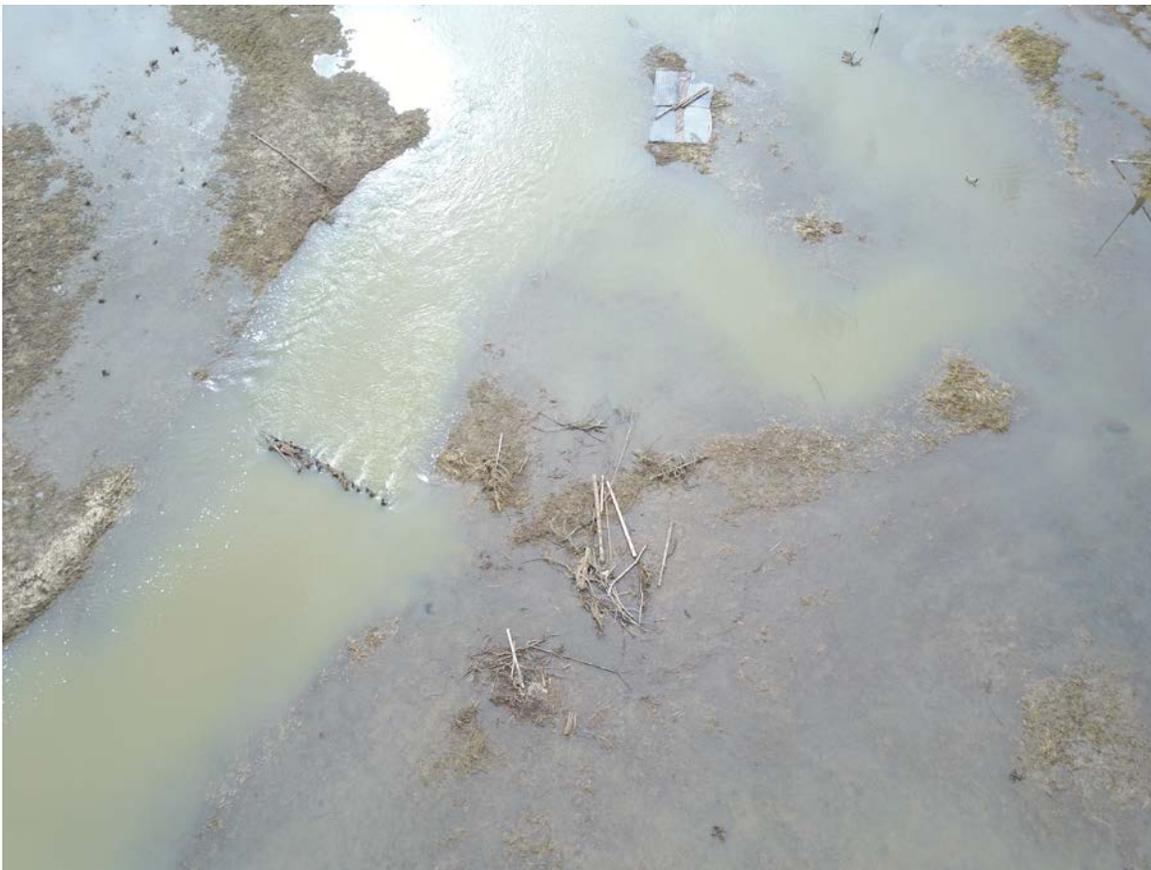
Figure 4. Aerial image of FBD on Big Bear Creek at high flow.

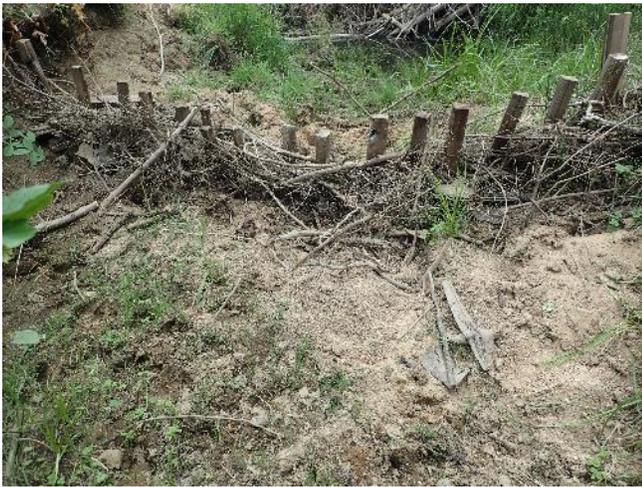
New sedimentation was noted at most structures, including the damaged FBD, and new beaver activity was discovered at two locations. In several cases, pools upstream of FBDs were holding water well into August. All the FBDs on Big Bear Creek had accumulated wood and sediment, and some were retaining water late in the summer.

Figure 5. Sediment accumulation at FBD

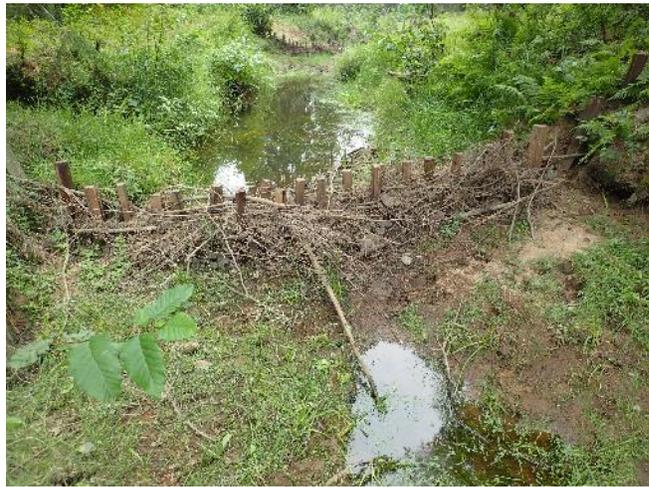
Figure 6. Pool created behind FBD

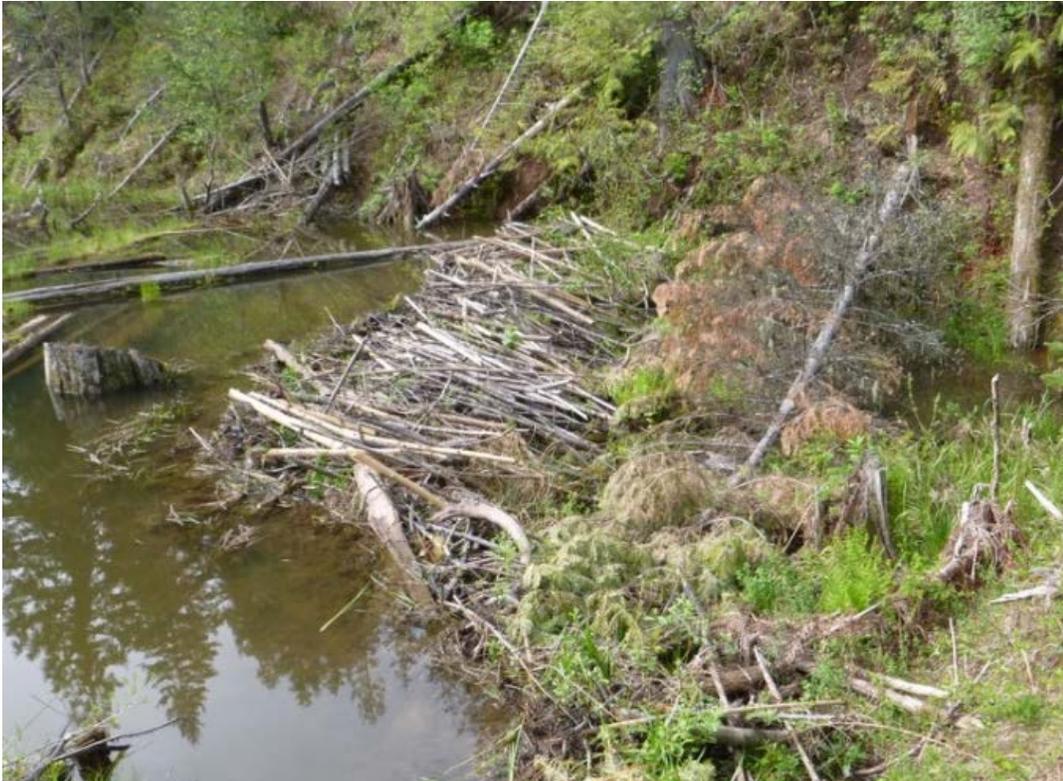
3. Always install angled sticks along the downstream side of the BFD to prevent scour. Beavers do in this area as shown in Figure 7.

Figure 7. Real Beaver Dam with Scour Protection
